Slope Stabilization Using Recycled Plastic Pins:

Phase II - Assessment in Varied Site Conditions

Final Report

Department of Civil and Environmental Engineering
University of Missouri - Columbia

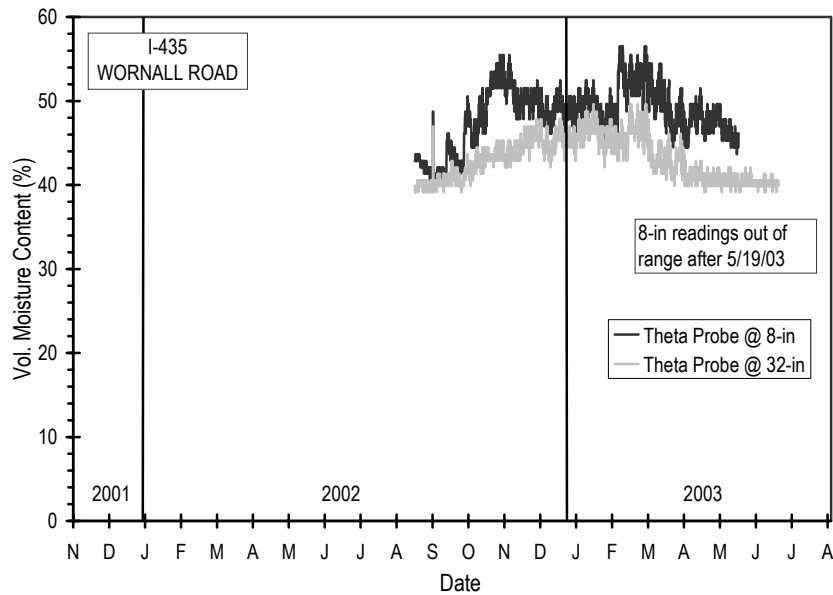
Figure 5.33 Volumetric water content from I435-Wornall Road test site.

Readings taken for the Equitensiometers[®], which measure soil suction directly, have consistently been out of range indicating that the soil has been essentially saturated since the sensors were installed. This further supports the piezometer readings for the shallow piezometers which suggest that positive pore pressures are present within the upper stratum. Readings taken for the ThetaProbes[®], which measure volumetric water content, are plotted in Figure 5.33. Readings for both ThetaProbes[®] indicate increasing water content during Fall 2002. Water contents for the upper ThetaProbe[®] then decreased between November 2002 and February 2003 while water contents for the lower ThetaProbe[®] remained essentially constant during this time. Both probes indicate a significant increase in water content in early February 2003 followed by generally decreasing water contents since that time.

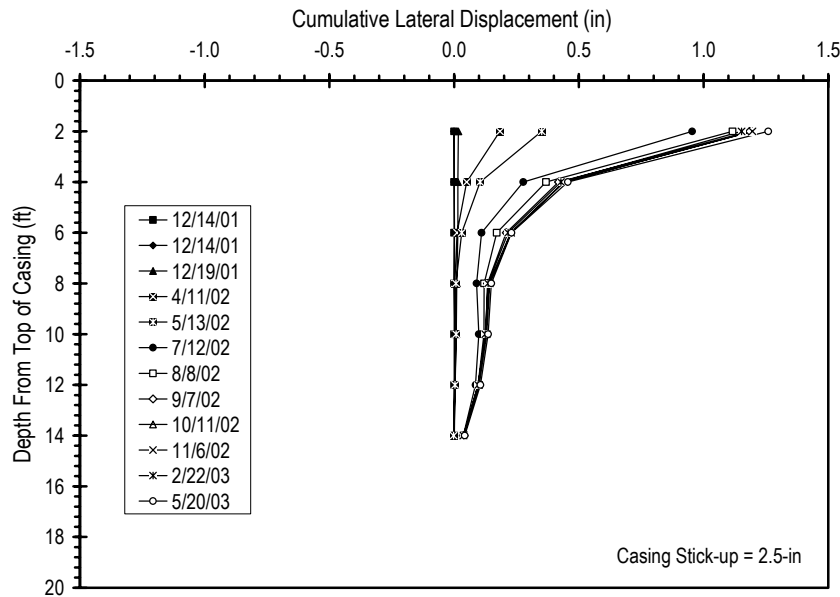
Figure 5.34 Lateral deflection profile for Inclinometer I-3 at I435-Wornall Road test site.

Inclinometers. Lateral deformations determined from inclinometers I-3 and I-4 are plotted in Figures 5.34 and 5.35, respectively. As shown in the figures, two different forms of deflection profiles have been observed in the inclinometers. Inclinometer I-3 indicates that maximum deformations are occurring near the ground surface with continuously decreasing deformations with depth. Inclinometer I-1 produced a similar profile with lower overall deformations. Inclinometer I-4 also shows that the maximum deformations are at the ground surface. However, I-4 also shows a significant discontinuity in the deformation

profile at a depth between 8- and 10-ft (2.4- and 3.0-m), which may be an indication of the formation of a sliding surface. Inclinometer I-2 produced a similar profile with a discontinuity between 10- and 12-ft (3.0- and 3.6-m).

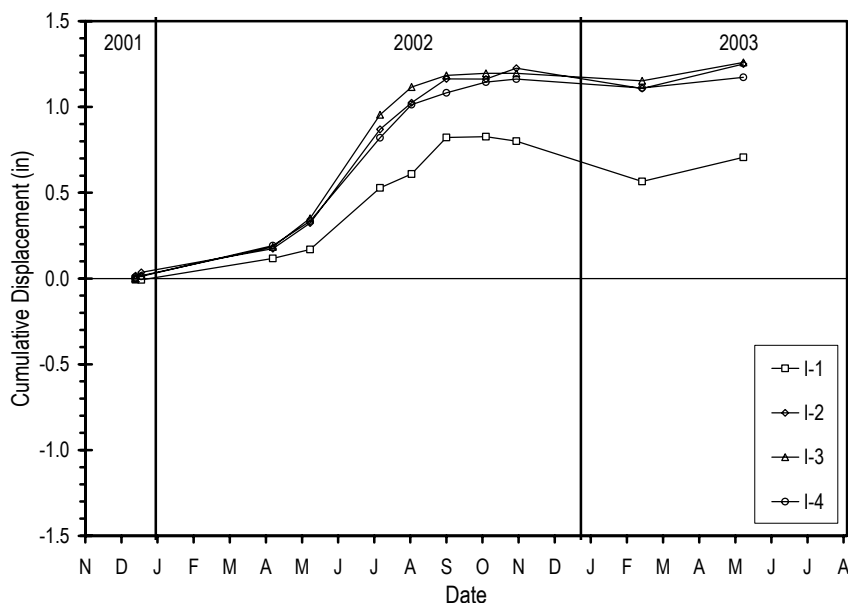
Figure 5.36 Cumulative lateral deflections for inclinometers I-1 through I-4 at the I435-Wornall Road test site.

Cumulative deformations for all four inclinometers are plotted as a function of time in Figure 5.36. This figure shows that all four inclinometers have a similar trend of deformation with time. Little movement was observed during the first few months following installation. Movements then increased substantially in April 2002 and continued to increase

throughout the summer until leveling out in August/September 2002. Movements since that time have generally been negligible. Maximum deformations for inclinometers I-2, I-3, and I-4 are approximately 1-in (2.5-cm) while deformations for inclinometer I-1 have been somewhat smaller.

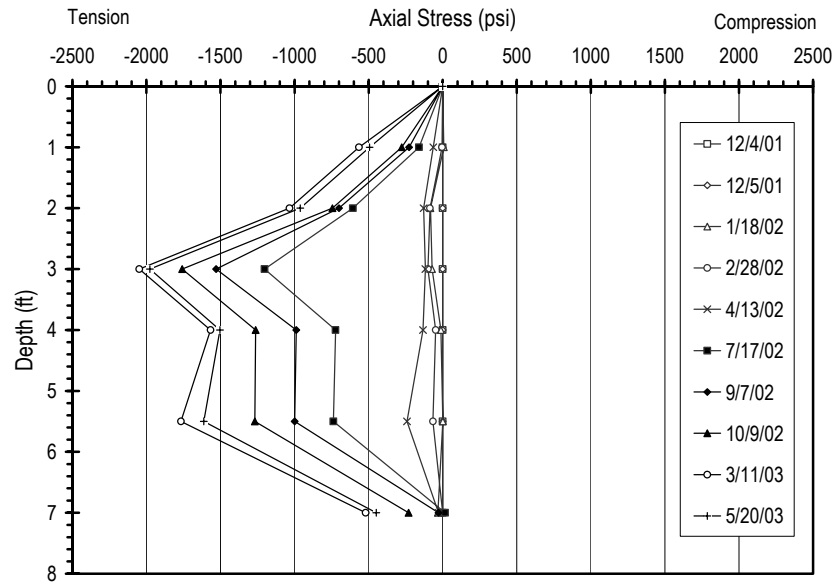
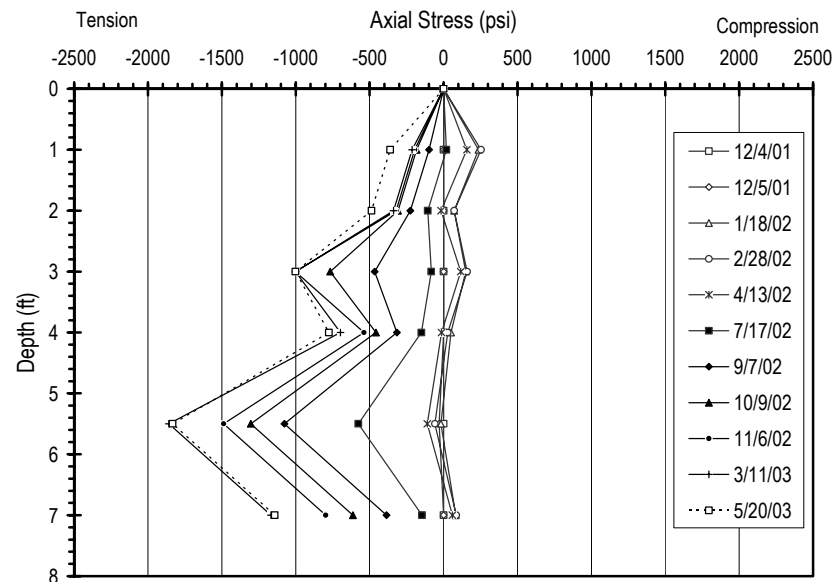
Figure 5.37 Measured incremental axial stresses in instrumented members at I435-Wornall Road test site: (a) IM-1 and (b) IM-3.

Figure 5.37 shows typical distributions of incremental axial stresses determined for the instrumented reinforcing members at the I435-Wornall Road test site. Members IM-1 and IM-2 had distributions of incremental axial stresses like that shown in Figure 5.37a, in which the maximum incremental axial stress is located near the midpoint of the member. In contrast, members IM-3 and IM-4 had distributions like the one shown in Figure 5.37b, with the maximum incremental stresses occurring at or near the tip of the members. Readings from all four instrumented members indicate development of tensile stresses since installation.

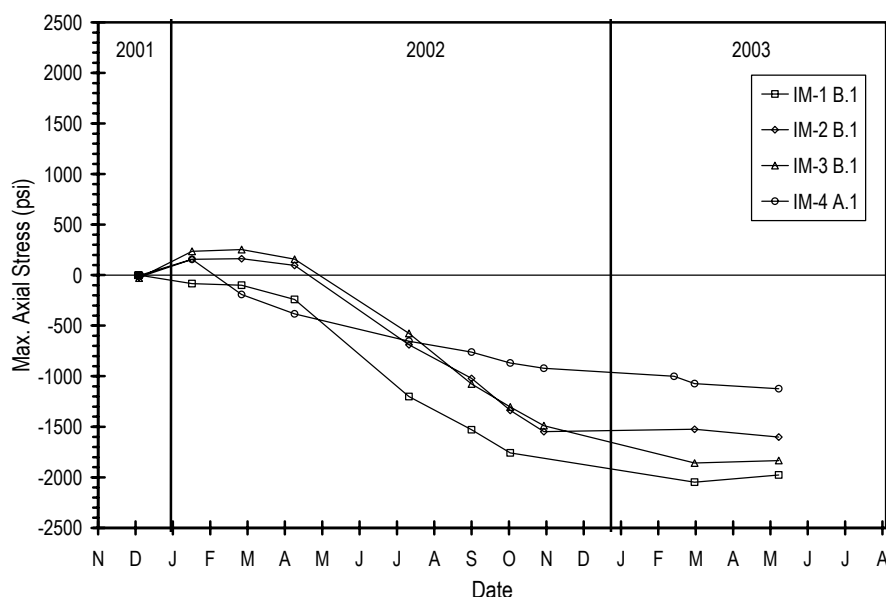
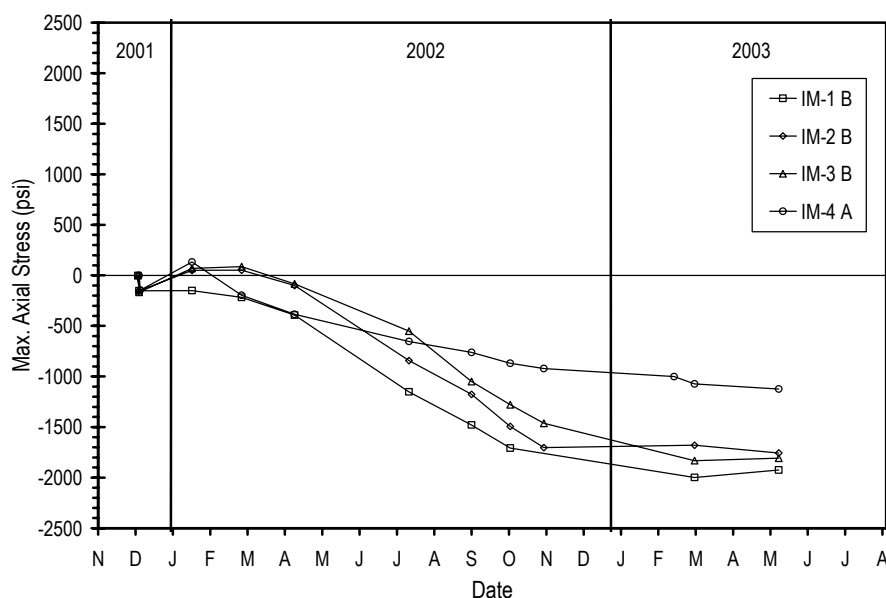
Figure 5.38 Maximum axial stress in instrumented members at I435-Wornall Road test site: (a) incremental axial stresses, and (b) overall axial stresses.

The maximum incremental and overall axial stresses in each member are plotted as a function of time in Figure 5.38. This figure shows that all four members had similar responses consisting of an initial period with little change in stress, followed by decreases in stress for a period of time, after which the axial stresses are essentially constant. The maximum incremental axial stresses for the four instrumented members ranged from approximately -1000- to -2000-psi (-6900- to -14,800-kPa). These stresses are much greater than those measured at other field sites as described in subsequent chapters. The initial axial stresses developed in the members during installation were small (<200 psi).

Results from instrumentation readings indicate that all four members have experienced tensile strains/stresses since installation as shown in Figure 5.38a. The reason(s) for the development of tensile strains/stresses in the members following installation is not entirely understood, but the trend has been consistently observed at all field test sites. One explanation currently being considered is that the observed tensile strains/stresses are a result of relaxation of compressive stresses induced in the members during installation. However, if this were true, it would suggest that the overall magnitude of the axial stresses would remain compressive or near zero, but would not become significantly negative since there is no apparent loading mechanism to induce tension. However, the data clearly indicate significant overall tensile strains/stresses, which does not support this hypothesis. It is possible that the strain gages may not have accurately captured the full magnitude of the strains induced during installation, which would suggest that the actual overall stresses (including installation induced stresses) were actually shifted by some unknown amount. Another possible contributor to the tensile strains/stresses could be a result of thermal strains produced by changes in temperature. However, there is no apparent trend to the strains

according to season so this is not believed to be a major contributor to the tensile strains. Additional interpretation efforts will be made in the future in an attempt to resolve this issue.

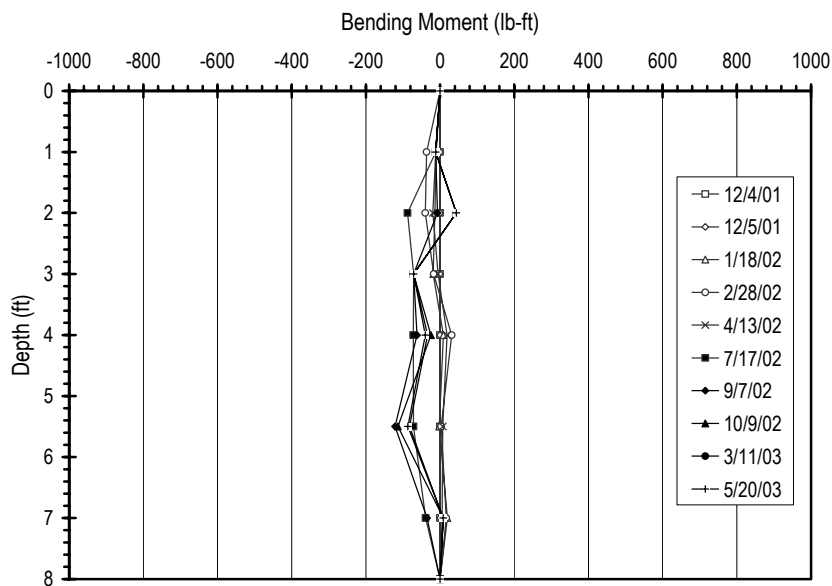
Figure 5.39 Measured incremental bending moments in instrumented member IM-1 at the I435-Wornall Road test site.

Figures 5.39 through 5.41 show the incremental distributions of bending moments determined for instrumented members IM-1, IM-2, and IM-4, respectively. The distributions of bending moments for these three members are distinctly different. Member IM-1 produced a roughly parabolic distribution of bending moments with depth, with all moments being negative (implying bending towards the crest of the slope). Member IM-2 also

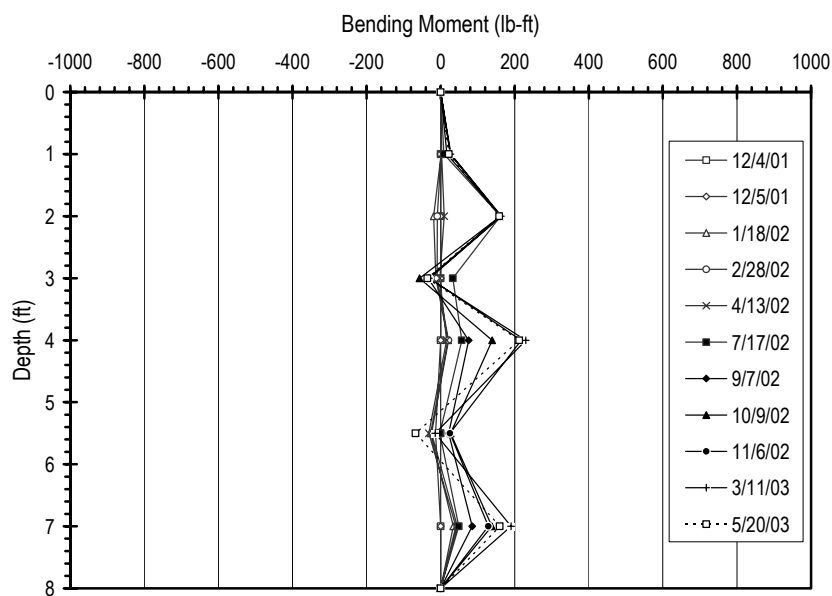
Figure 5.40 Measured incremental bending moments in instrumented member IM-2 at the I435-Wornall Road test site.

produced a roughly parabolic distribution of bending moments, but with all moments being positive (implying bending towards the toe of the slope). One would expect that the bending moments in these two members would be very similar given their close proximity on the slope so the difference in the sign of the moments is perplexing. Member IM-3, located near the toe of the slope produced a distribution similar to IM-2. Member IM-4 has a somewhat different distribution of moments, with positive moments near the top of the member, near zero moments near the center of the member and positive moments in the lower portion of the member.

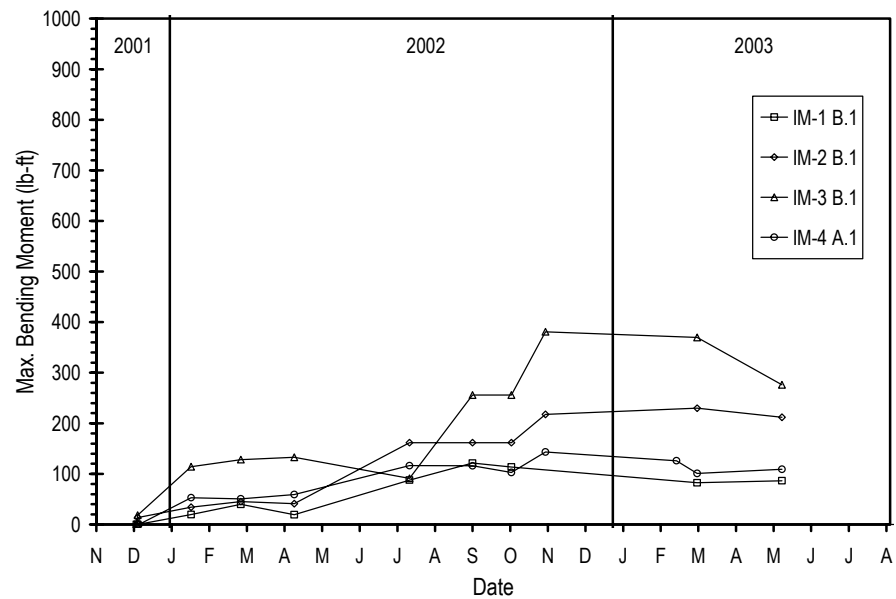
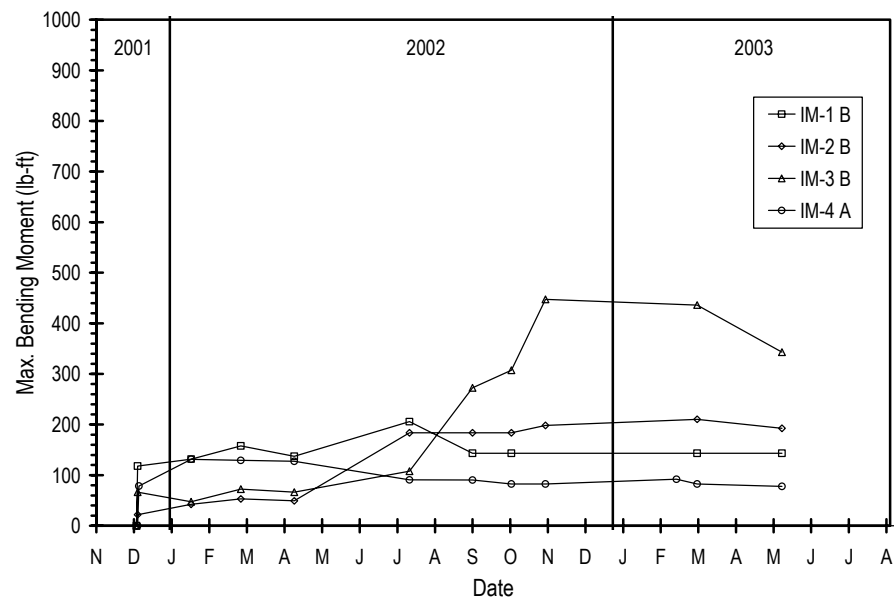
Figure 5.42 Maximum bending moments in instrumented members at I435-Wornall Road test site: (a) incremental bending moments and (b) overall bending moments.

Figure 5.42 shows the maximum bending moments determined for each instrumented reinforcing member plotted as a function of time. As shown in Figure 5.42b, the initial bending moments developed during installation generally ranged from 20- to 120-lb-ft (27-160-N-m). Incremental bending moments in each member remained relatively low for several months followed by a period of relatively steady increases in the bending moments during and just following the period of high precipitation between April and June 2002.

Since that time the maximum bending moments have remained steady, even during the spring of 2003. Member IM-3, located near the toe of the slope where pore pressures have been highest, has experienced the largest incremental and overall bending moments. However, these moments remain below 500-lb-ft (680-N-m), which indicates that the members have significant excess capacity remaining and are not near failure (nominal capacity is 1000-lb-ft).

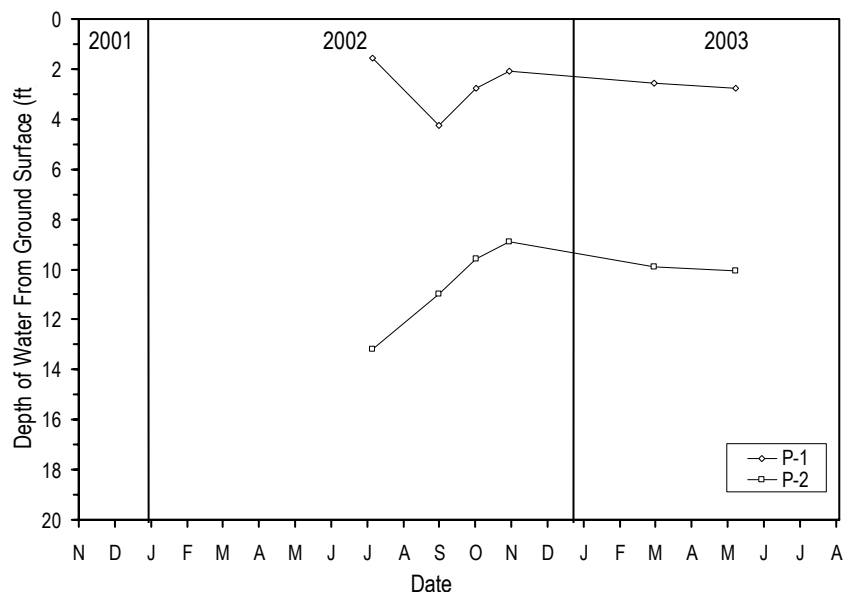
Figure 5.43 Piezometric water levels measured at I435-Holmes Road test site.

Measured piezometric water levels recorded at the I435-Holmes Road site are plotted in Figure 5.43. These data again indicate the presence of a perched water condition within the slope. The piezometric levels seem to be somewhat less responsive to rainfall events than

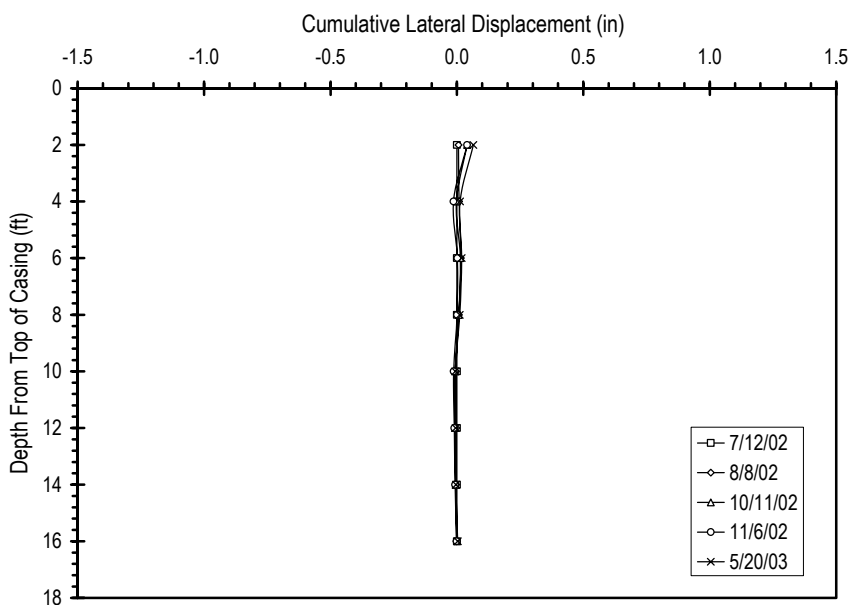
Figure 5.44 Lateral deflection profile for Inclinator I-1 at I435-Holmes Road test site.

those measured at the I435-Wornall Road site, particularly during Spring 2003. Figures 5.44 and 5.45 show the lateral deformations determined at the I435-Holmes Road and I435-Control sites, respectively. To date, neither inclinometer has experienced any significant movement. Measured incremental axial stresses and bending moments in instrumented members in the I435-Holmes Road slope have also been negligible.

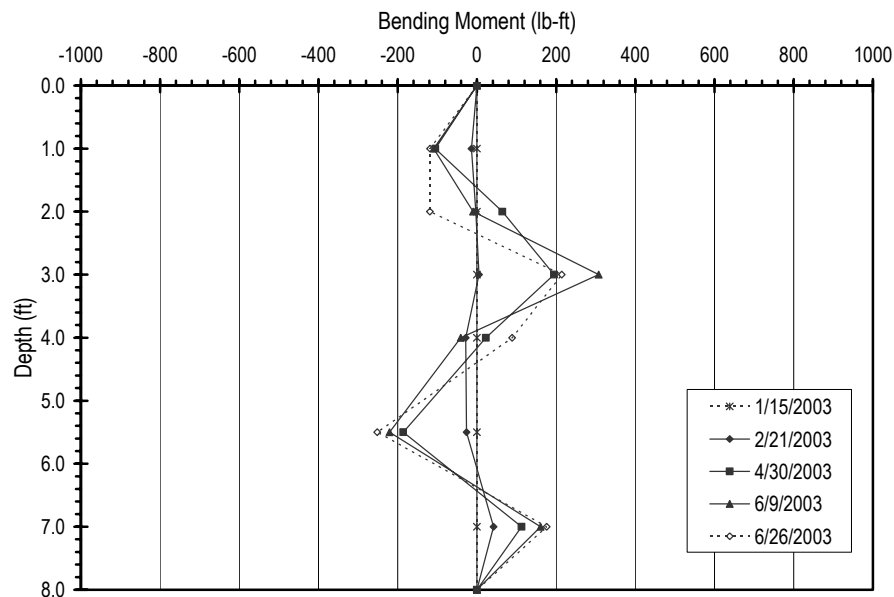
Two different forms of bending moment distributions have been observed for the instrumented members at the US54-Fulton site as shown in Figures 8.16 and 8.17 for members IM-25 and IM-8, respectively. Members IM-25, IM-10, IM-16, and IM-20 all showed S-shaped distributions of bending moments with positive bending moments in the upper portion of the member and negative bending moments in the lower portion (Fig. 8.16). Members IM-8 and IM-21 had bending moment distributions with positive moments along the entire length of the member with the maximum bending moment occurring at a depth of

Figure 8.16 Measured incremental bending moments for instrumented member IM-25 at the US54-Fulton test site.

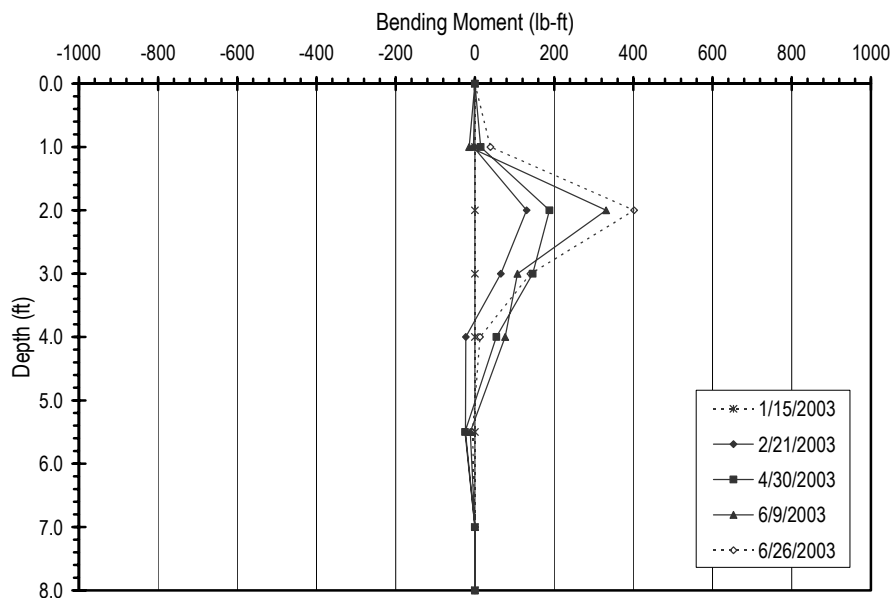
Figure 8.17 Measured incremental bending moments for instrumented member IM-8 at the US54-Fulton test site.

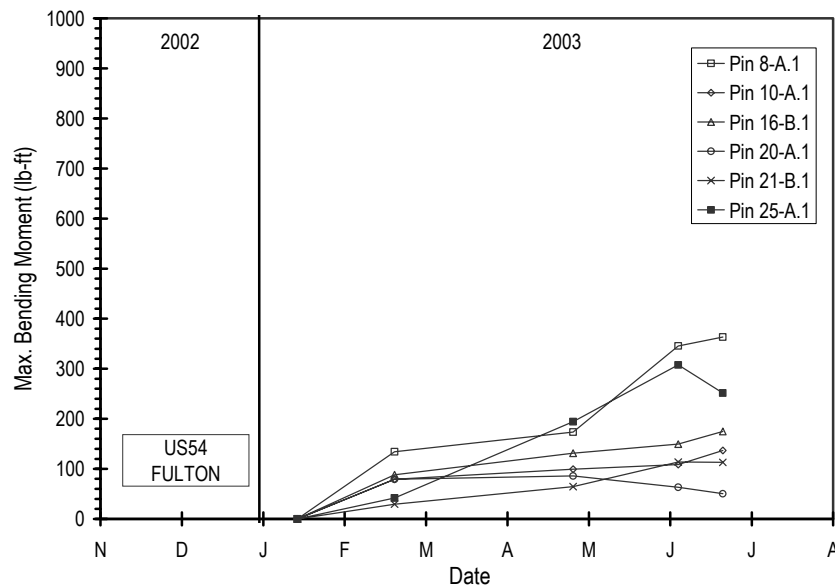
Figure 8.18 shows the maximum bending moments measured in each of the instrumented reinforcing members from the US54-Fulton site plotted as a function of time. To date, the incremental bending moments measured for each of the members have increased with time but remain relatively small. The maximum bending moments for members IM-10,

IM-16, IM-20, and IM-21 have increased in an approximately linear manner. All of these members have maximum bending moments that are less than 200-lb-ft (270-N-m). In contrast, maximum bending moments for members IM-8 and IM-25 increased at an increasing rate between February and June 2003 and both of these members have experienced maximum incremental bending moments of approximately 300-lb-ft (400-N-m), which is significantly higher than that determined for the other members at the site. No clear reason is apparent for the higher bending moments for these two members; however, they are both located in close proximity to one another in the lower portion of the slide in Sections B and C.

Figure 8.18 Maximum incremental bending moment in instrumented members at US54-Fulton test site.
